M483 PROJECTILE SHORT TERM STICKER INVESTIGATION

INTERIM STATUS REPORT ON THE M483 PROJECTILE SHORT TERM STICKER INVESTIGATION

R. CORN
Systems Engineer for
M483 Projectile Investigation

6 July 1975

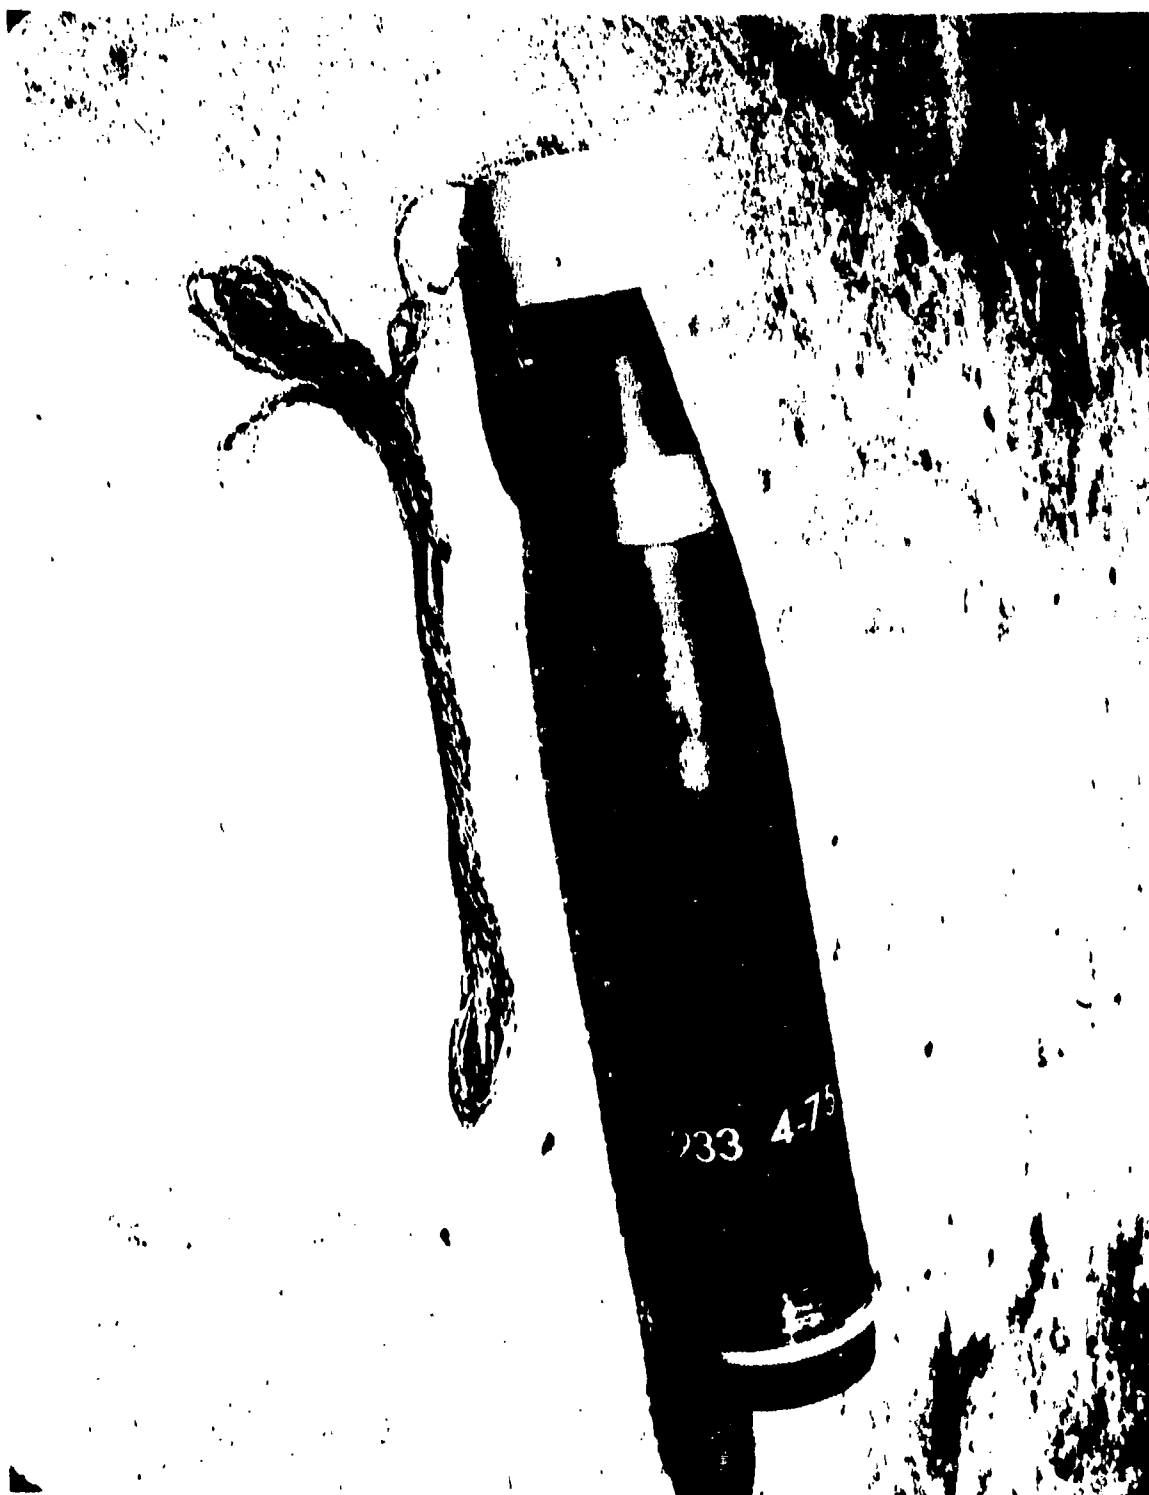
(Figure 21) Figure 21 shows the assembly mounted to the ogive of an M483 projectile. When the projectile is rammed the wire is run out the front of the tube to data recording equipment. As the projectile moves down the tube the wire is collected in the collector cup.
